Manhole Inspection Summary

Manhole # S11II1039MH

Location Address: **4515 UMATILLA DR** Cross Street: **RIDGEWOOD AVE**

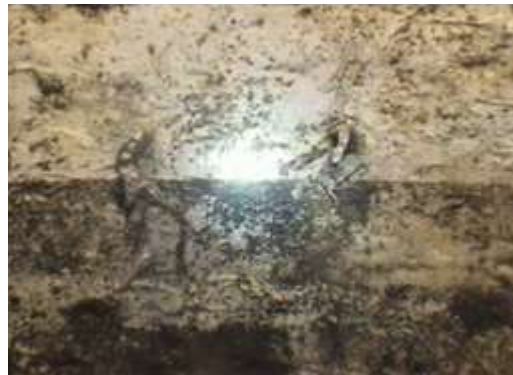
Defect 1

Steps Count: **5** Missing: **2** ☒ **Corroded**

MISSING CORRODED RUNG

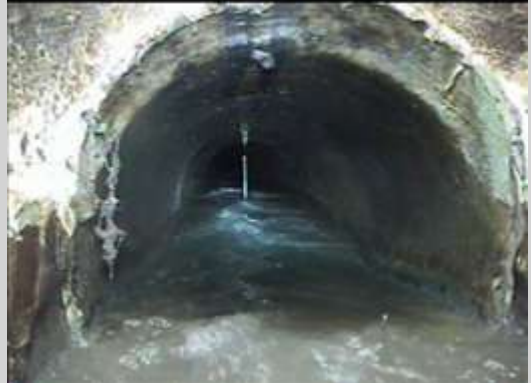
12 O'Clock Outflow

18 in. Circular Gravity Sewer
Pipe Out @ 12 O'Clock

Pipe Height: **19.2** (in.) Rod and Bar (Angled)
Pipe Material: **PVC** ☐ Pipe Lined
Invert Depth: **9.89** (ft.) Flow Characteristics: **Fast**
Deposits: ☒ None ☐ Mud ☐ Sludge ☐ Debris ☐ Grease
Silt Depth: (in.) Deposits Extent:
Infiltration: **None** Pipe Seal Cond: **Sound**

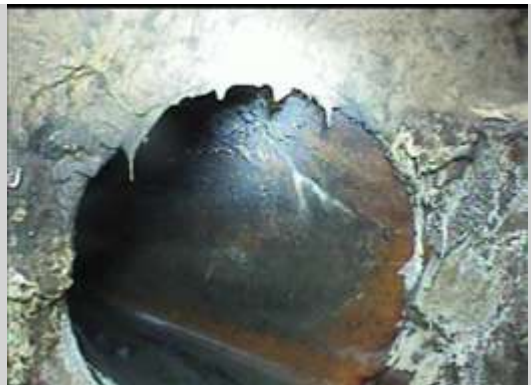
3 O'Clock Inflow

8 in. Circular Gravity Sewer
Pipe In @ 3 O'Clock

Pipe Height: **8.4** (in.) Rod and Bar (Angled)
Pipe Material: **Clay** ☐ Pipe Lined
Invert Depth: **9.19** (ft.) Flow Characteristics: **Slow**
Deposits: ☒ None ☐ Mud ☐ Sludge ☐ Debris ☐ Grease
Silt Depth: (in.) Deposits Extent:
Infiltration: **None** Pipe Seal Cond: **Sound**

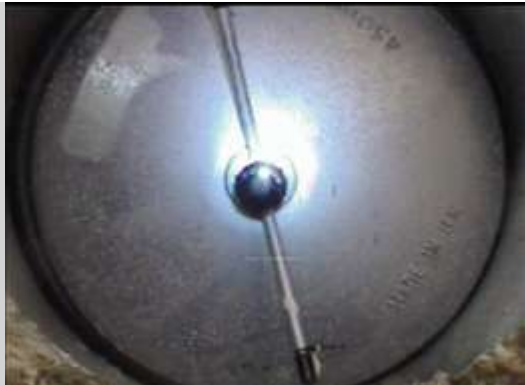
3 O'Clock Outflow

18 in. Circular Gravity Sewer
Pipe Out @ 3 O'Clock

Connects To: **Stub connection / abandoned**

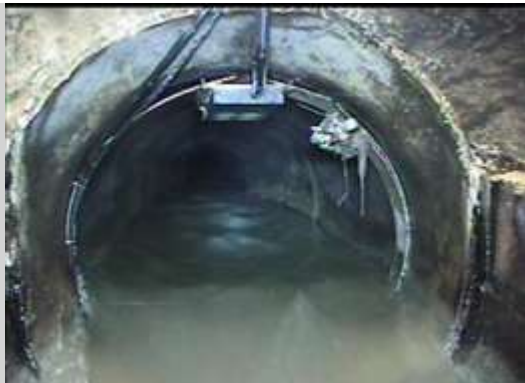
6 O'Clock Inflow

18 in. Circular Gravity Sewer
Pipe In @ 6 O'Clock

Pipe Height: **20.4** (in.) Rod and Bar (Angled)

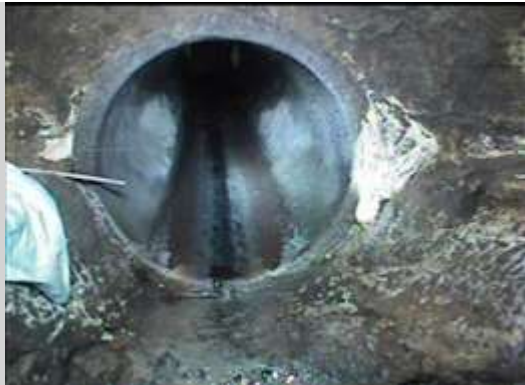
9 O'Clock Inflow

8 in. Circular Gravity Sewer

Pipe In @ 9 O'Clock

Pipe Height: **8.4** (in.) Rod and Bar (Angled)
